# Preliminary Design of the Highway 11 2+1 Roadway Model Pilot Project: GWP 5151-21-00

Fish and Fish Habitat Existing Conditions Report

Ontario Ministry of Transportation

May 2025

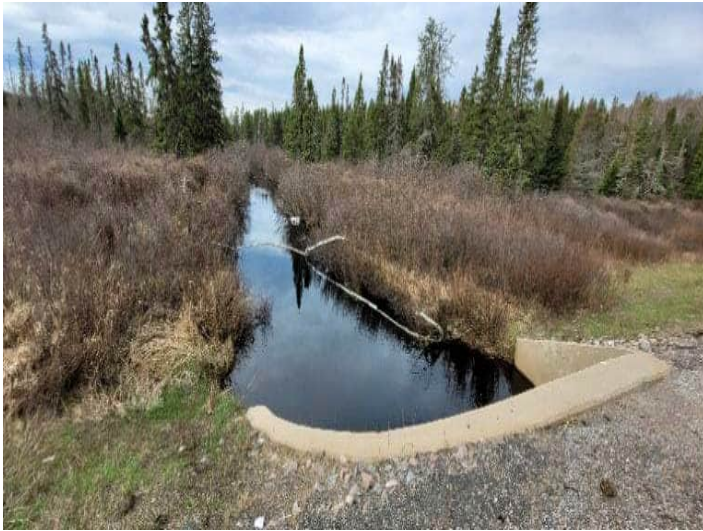
**Photograph 1** ↑

Spill containment and cleanup measures (i.e., spill socks, containment boom) were observed on the water's surface in the downstream ZDA. These were observed in both the spring and the summer assessments. It is presumed these measures were deployed to address a spill in the watercourse, however it was undetermined whether they had been abandoned, or spill cleanup spanned over the course of the spring and summer.

**Merrick – 15+975:** May 3, 2024. View of downstream Zone of Detailed Assessment (ZDA), facing downstream (south). Spill socks present on water's surface, view from Highway 11 culvert.

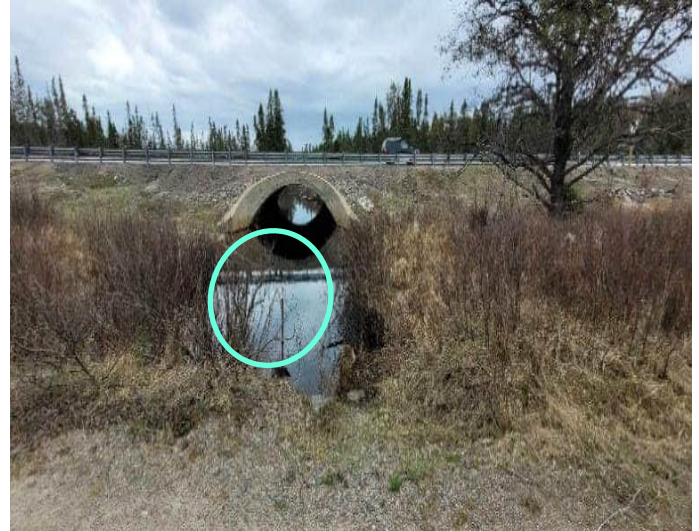
**Photograph 2** ↑

**Merrick – 15+975:** May 3, 2024. View of upstream ZDA, facing downstream (southwest) from Stewart Hammel Road. Suitable habitat for Brook Trout (*Salvelinus fontinalis*) spawning habitat observed in this zone.

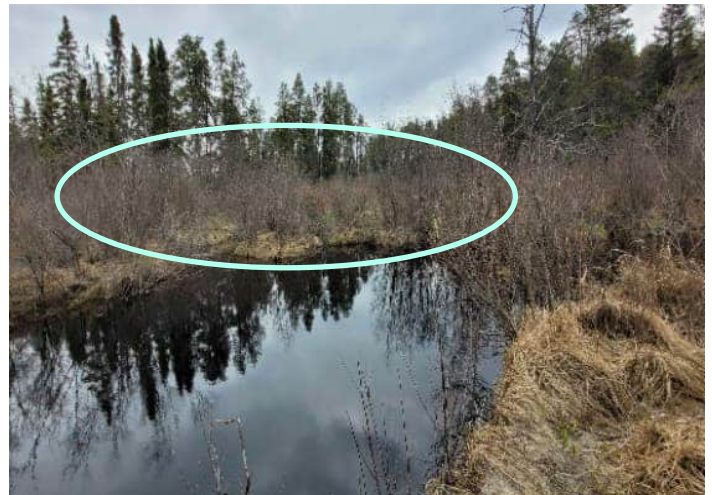
**Photograph 6** ↑

**Merrick – 15+975:** May 3, 2024. View of suitable spawning habitat for Northern Pike (*Esox lucius*) on left bank upstream of Stewart Hammel Road, facing northwest.

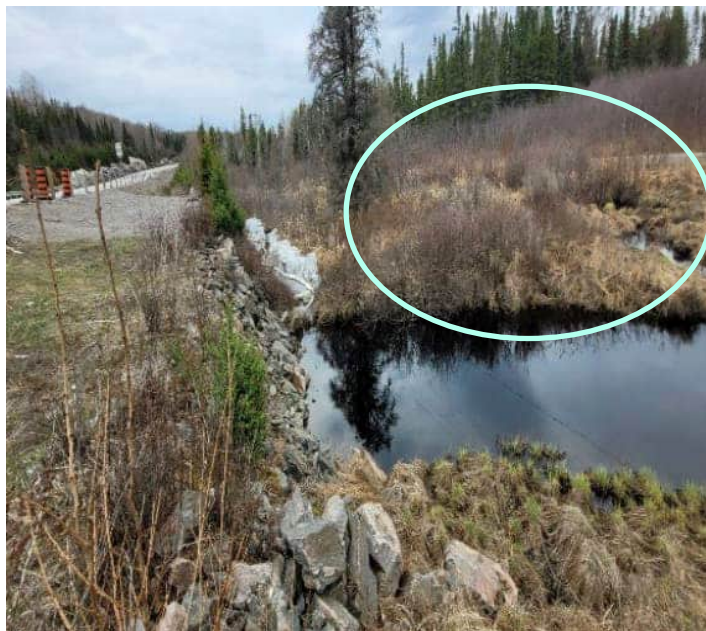
**Photograph 7** ↑

**Merrick – 16+035:** May 3, 2024. View of upstream ZDA, facing northwest. No crossing structure; natural channel filled in for highway causeway. Channel straightened to re-direct flow at 15+975. Suitable spawning habitat for Northern Pike.

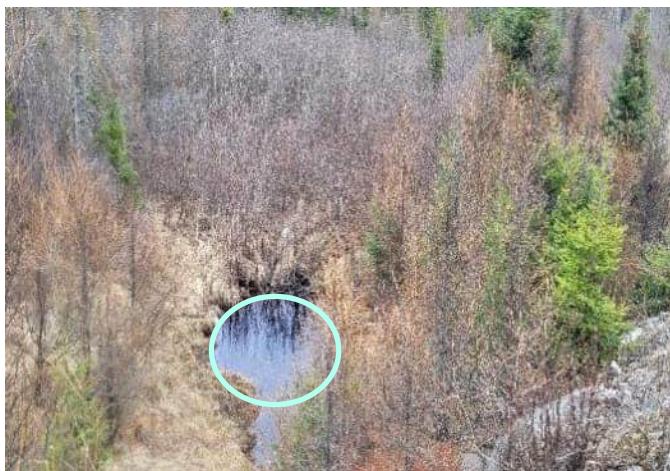
**Photograph 11** ↑  
**Blyth – 12+725:** April 29, 2024. View of upstream ZDA, facing upstream (northeast) from highway. Boulders at crest of inlet pool may impede fish passage.

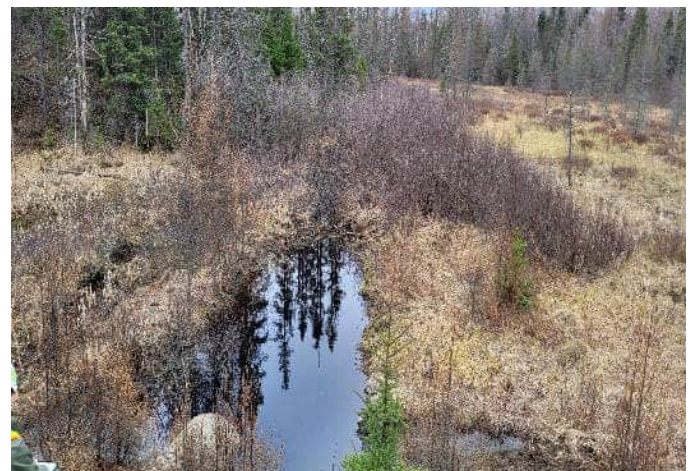
**Photograph 12** ↑  
**Blyth – 12+725:** April 29, 2024. View of downstream ZDA from highway, facing downstream (west). Channel narrows through wetland beyond outlet pool.

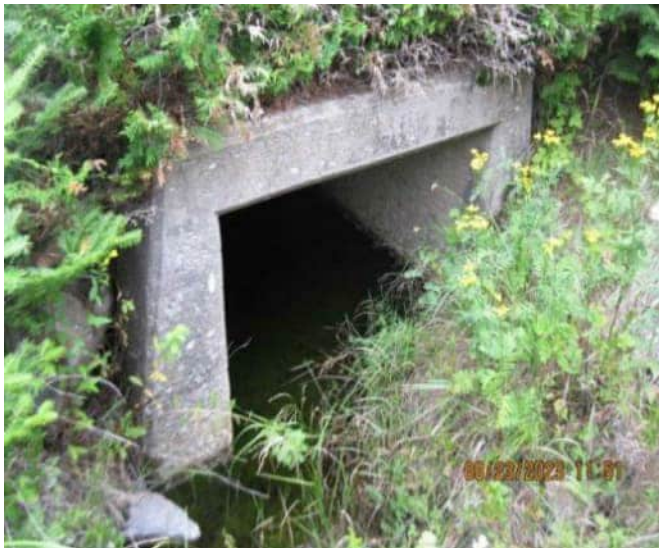
**Photograph 25** ↑  
**Blyth – 15+512:** August 23, 2023. Downstream. Conditions at culvert outlet from AECOM Culvert Inspection Report (2024).

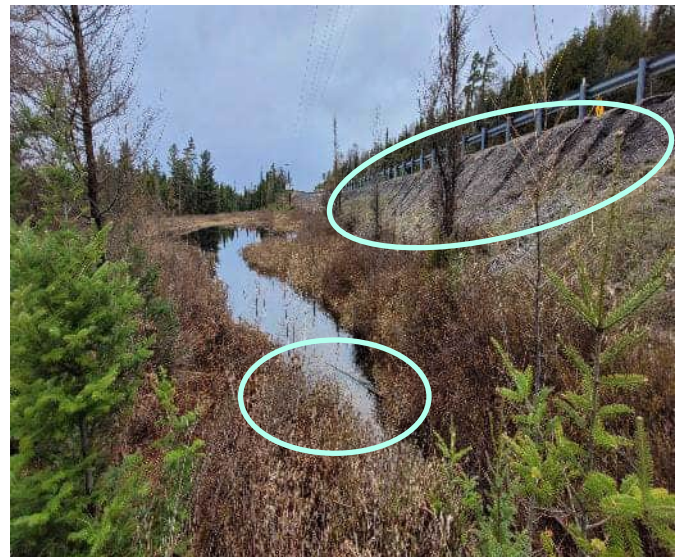
**Photograph 26** ↑  
**Blyth – 15+512:** April 30, 2023. View of the downstream ZDA, facing downstream (northwest) along channel to wetland. Embankment erosion is shown, and deposited material was observed in this channel.

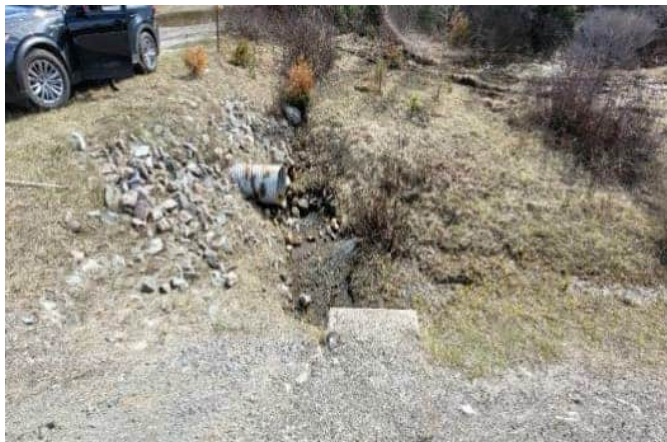
**Photograph 47 ↑**  
**Notman –14+926:** May 2, 2024. View of upstream ZDA. Facing upstream (southwest) from highway towards perched entrance culvert.

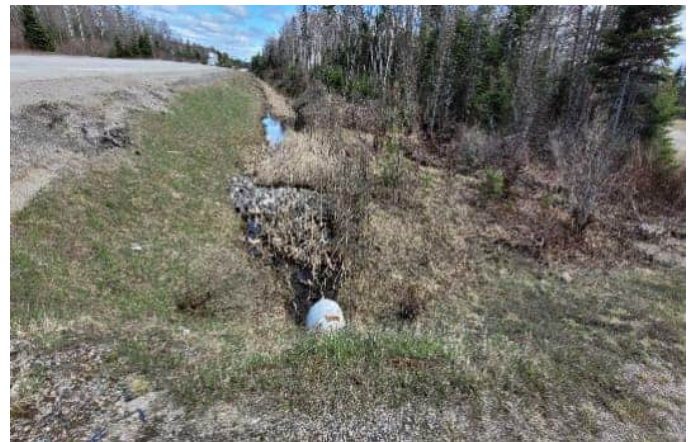
**Photograph 48 ↑**  
**Notman –14+926:** May 2, 2024. View of upstream ZDA. Facing upstream (southeast) from entrance along ditchline. Perched entrance culvert (Photo 53) and riprap in ditch are both fish passage impediments..

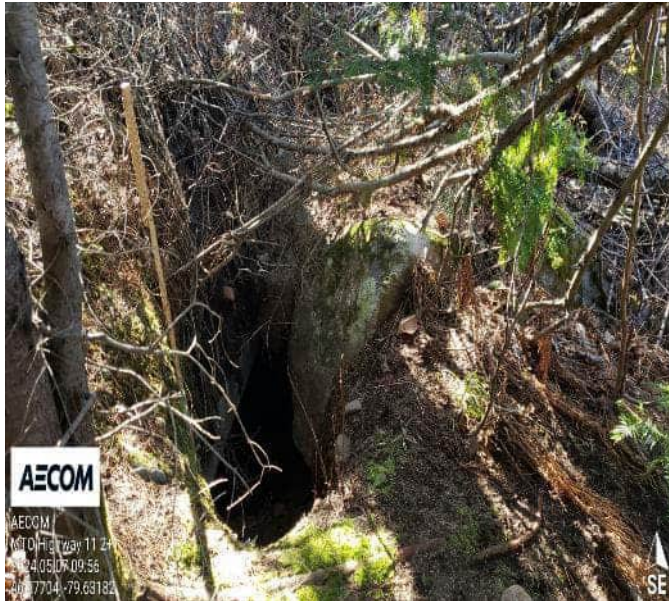
**Photograph 53** ↑  
Notman – 16+278 : May 7, 2024. Buried culvert outlet

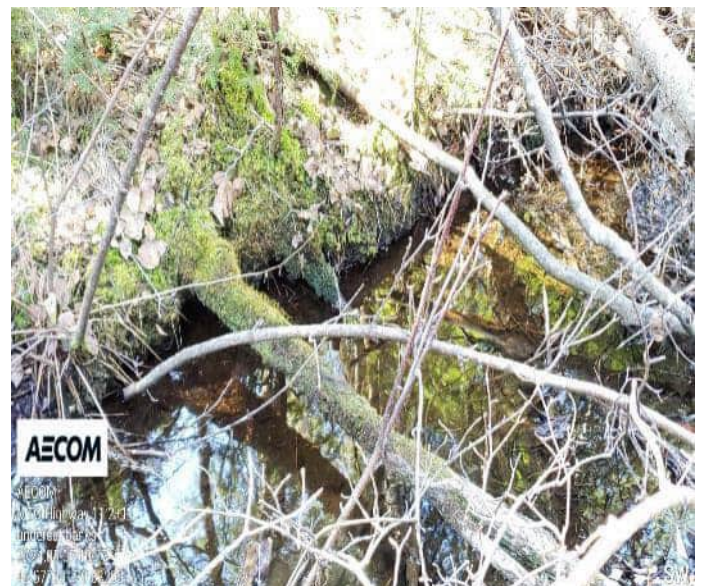
**Photograph 56** ↑  
Notman – 16+278: May 7, 2024. Defined channel with undercut banks downstream of culvert in ZDA.
