# Preliminary Design of the Highway 11 2+1 Roadway Model Pilot Project: GWP 5151-21-00

Fish and Fish Habitat Existing Conditions Report

Ontario Ministry of Transportation

May 2025

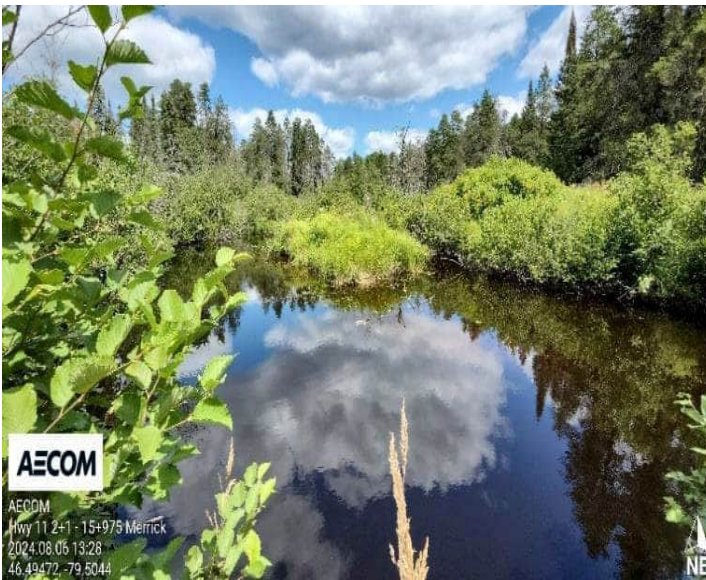
**Photograph 3** ↑

**Merrick – 15+975:** August 6, 2024. View of upstream ZDA, facing upstream (northeast) from Stewart Hammel Road crossing.

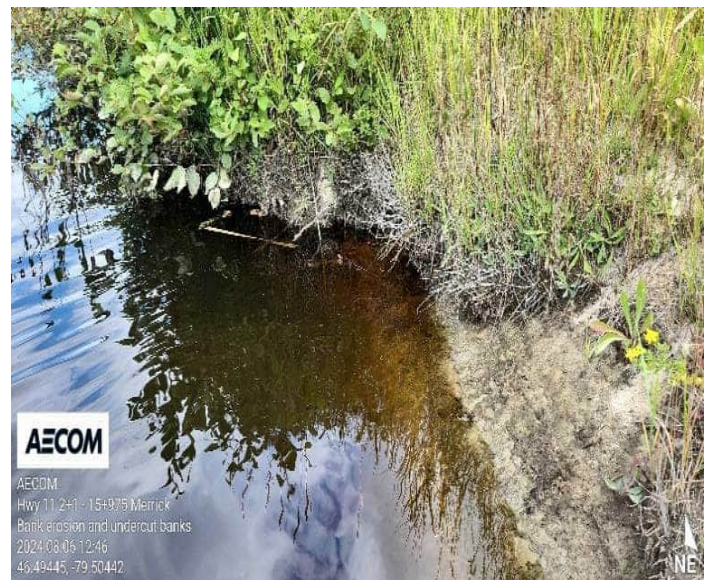
**Photograph 4** ↑

**Merrick – 15+975:** August 6, 2024. Upstream ZDA. Exposed soil and undercut banks directly upstream of Highway 11, facing right bank.

Rills and gullies were observed along the highway embankment in multiple locations, and in some instances, what appeared to be embankment material was observed in watercourses that had been deposited on the streambeds and/or transported downstream. Those locations where this was observed at or near fish-bearing waterbodies are listed in **Table 4** and shown in **Figure 2** in **Appendix A**. Measures to stabilize embankments throughout the Project area, but in particular those areas near fish habitat, should be explored to prevent further erosion of embankment material into watercourses or other adjacent natural features.

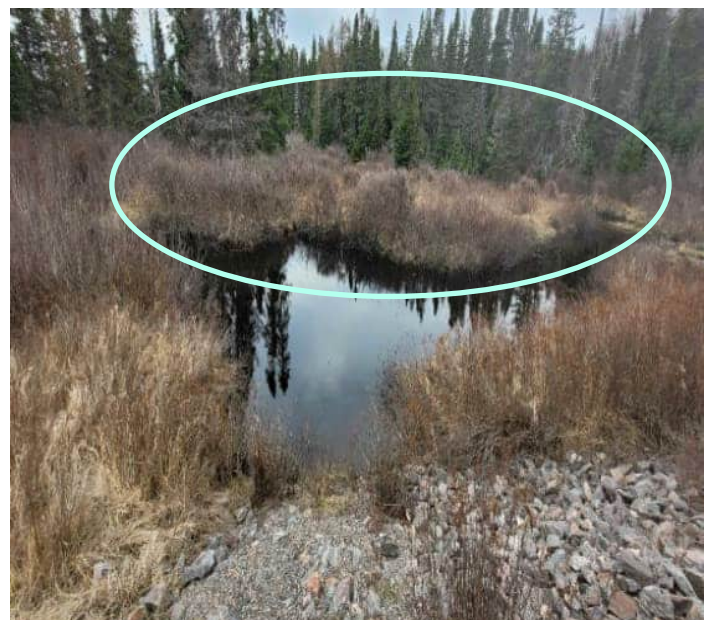
**Photograph 8** ↑

**Merrick – 16+035:** May 3, 2024. View of downstream ZDA and suitable spawning habitat for Northern Pike, facing downstream (south).

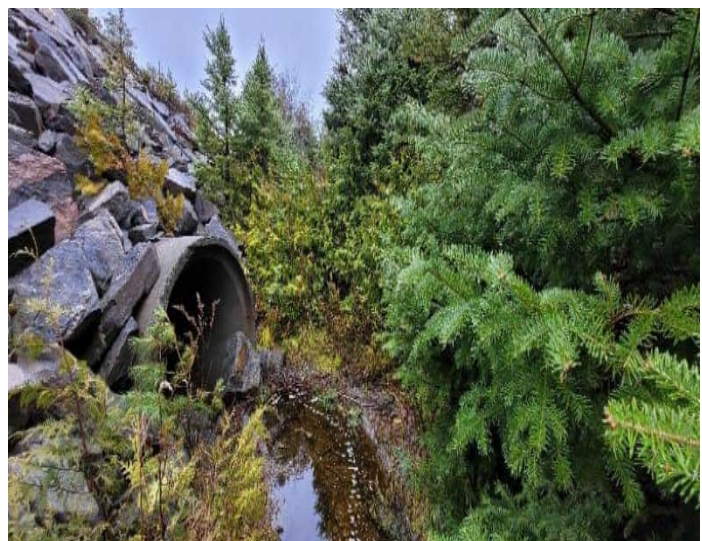
**Photograph 16** ↑

**Blyth – 13+400:** April 30, 2024. View of upstream ZDA and culvert inlet, facing downstream (northwest). Boulder and debris at inlet one of several potential fish passage impediments.

Impediments to fish passage were identified at several locations. In some instances, these impediments were found to be a result of the natural topography of the surrounding landscape and stream gradient or related to natural processes such as seasonal low flows and beaver activity. However, fish passage issues were noted at some locations that were attributed to anthropogenic structures, fallen trees, or debris that could conceivably be remedied as part of the Project works. If works are proposed at: 12+725 Blyth Township, 13+400 Blyth Township, 15+512 Blyth Township, 11+800 Notman Township, 14+073 Notman Township, 14+926 Notman Township, 16+060 Notman Township, and 16+278 Notman Township, removal of such material that impedes fish passage should be considered. At culverts where the impediments identified would require more substantial measures to remediate passage issues (i.e., grade or perch correction), such measures should be taken into account during the design depending on the nature of the work that is proposed. These could include those culverts proposed for extension, rehabilitation, or replacement. These locations include 13+400 Blyth Township, and 14+926 Notman Township (entrance culvert).

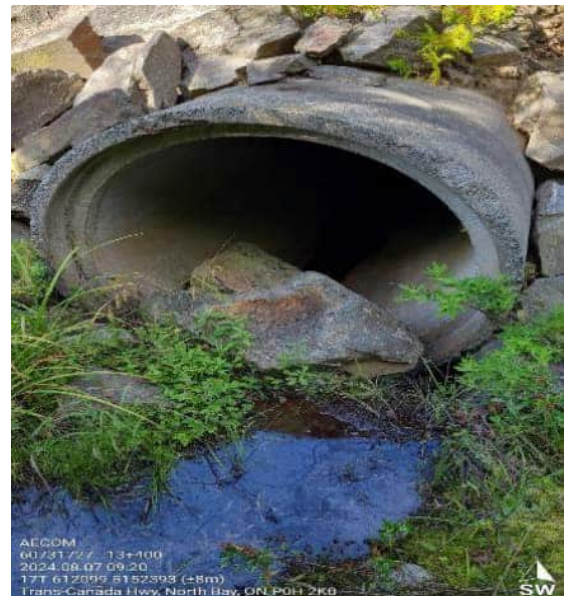
**Photograph 20** ↑

**Blyth – 13+400:** August 7, 2024. View of culvert inlet facing southwest. Boulder and debris at inlet one of several potential fish passage impediments.

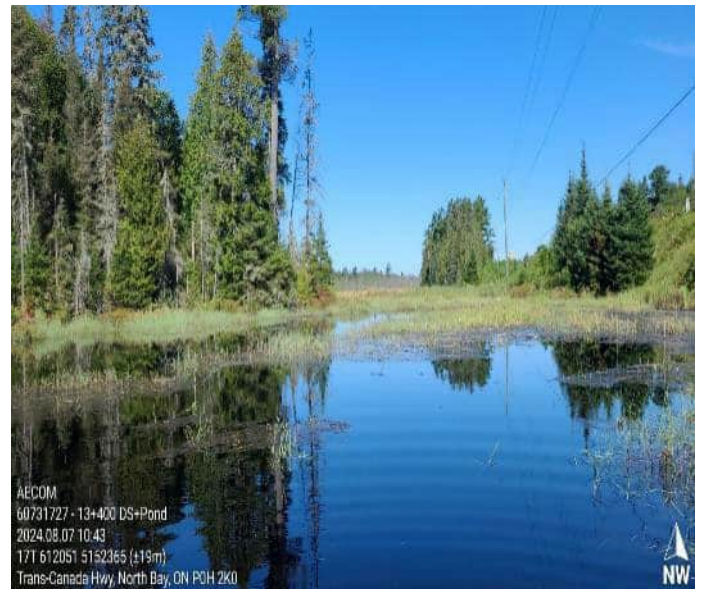
**Photograph 22** ↑

**Blyth – 13+400:** August 7, 2024. View of downstream ZDA, facing upstream (northwest) in the receiving online beaver pond flowing southerly and parallel to Highway 11 on the southwest side.

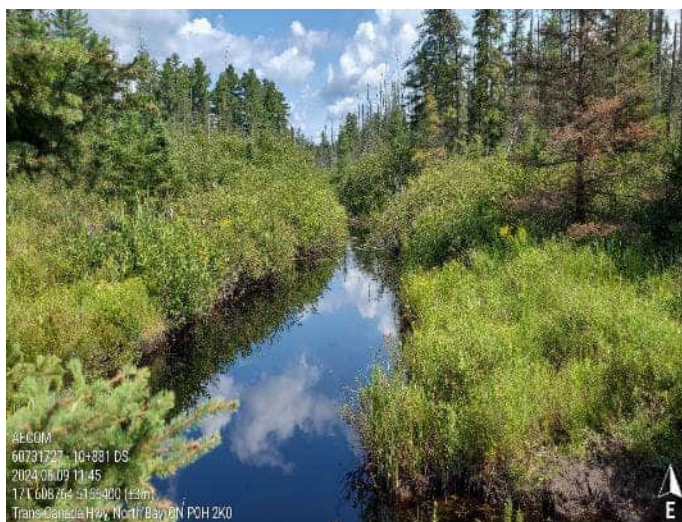
**Photograph 27** ↑  
**Notman – 10+881:** August 9, 2024. View of downstream ZDA. Facing downstream (northeast) from the culvert outlet.

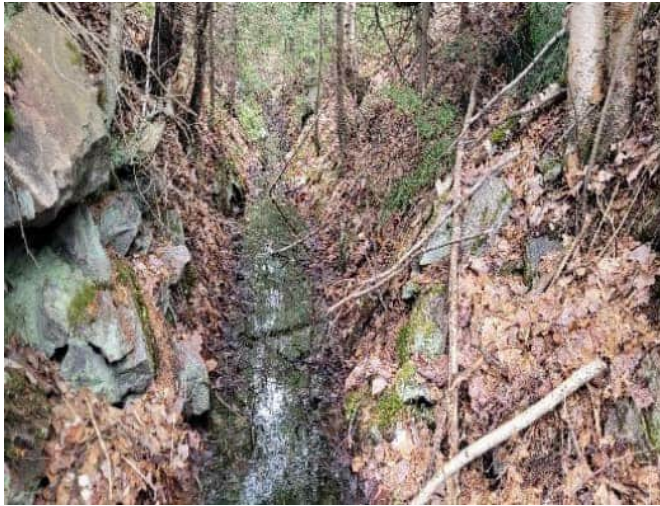
**Photograph 45 ↑**  
**Notman – 14+408:** May 3, 2024. View of straightened channel in downstream ZDA. Facing downstream (northeast).

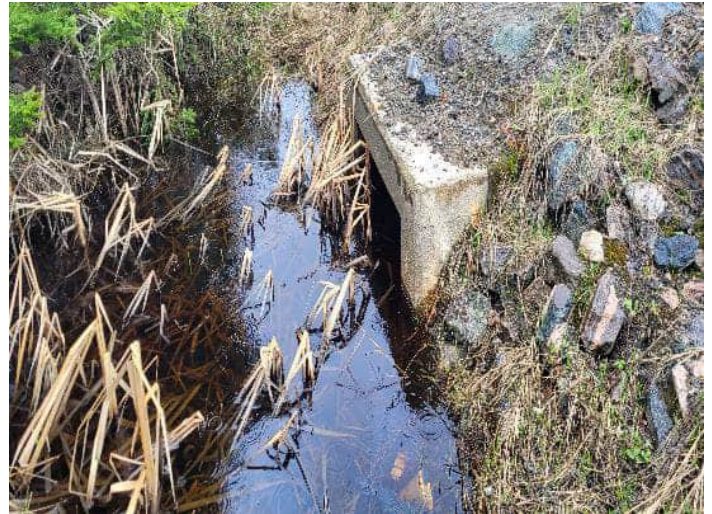
**Photograph 46 ↑**  
**Notman – 14+408:** May 3, 2024. View of culvert outlet.

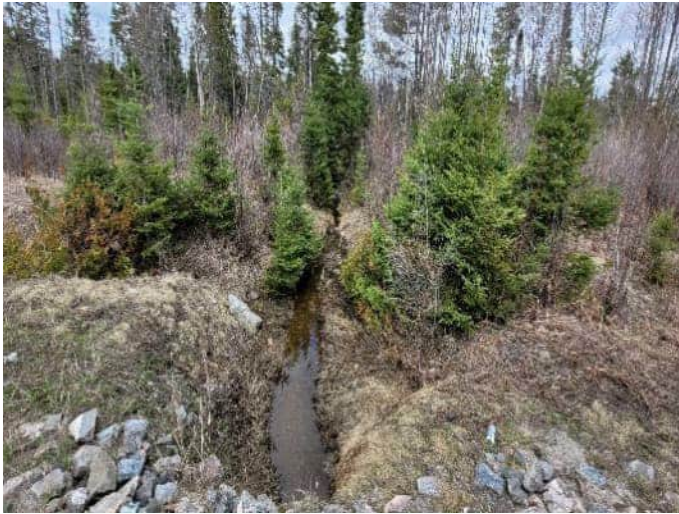
**Photograph 49** ↑

**Notman –14+926:** May 2, 2024. View of downstream ZDA, facing downstream (northeast) from highway.

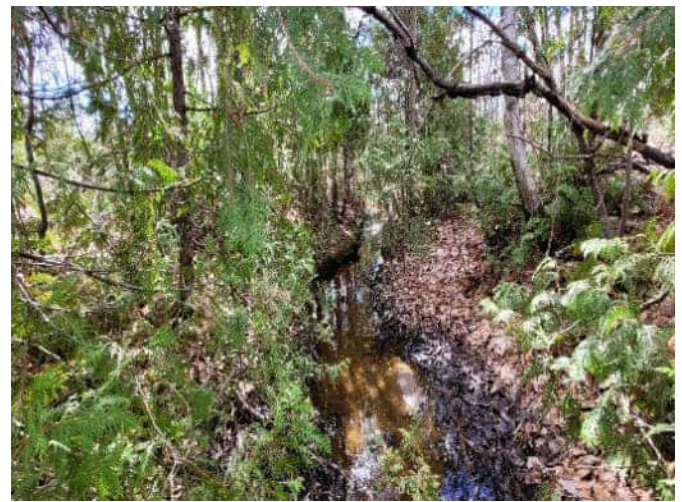
**Photograph 50** ↑

**Notman –14+926:** May 2, 2024. View of downstream ZDA, facing upstream (southwest) where defined channel travelled through forest between cattail marsh and highway. Suitable Brook Trout spawning substrate was observed in this section.

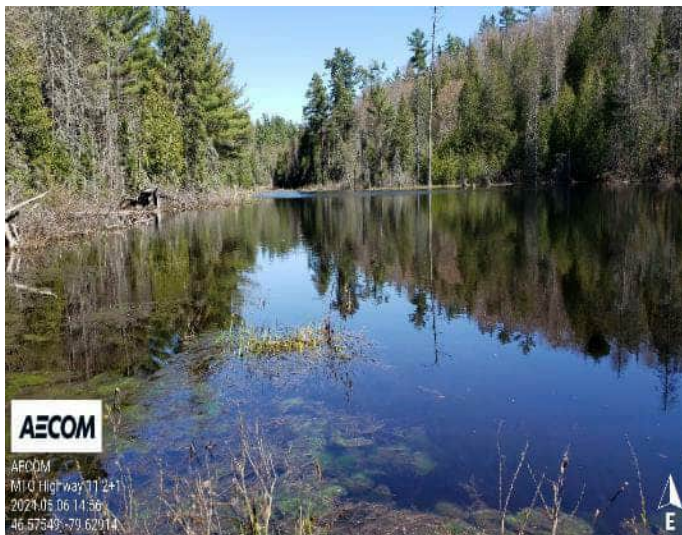
**Photograph 51** ↑

**Notman – 16+060:** May 6, 2024. View of upstream ZDA. Facing upstream (east) from highway.

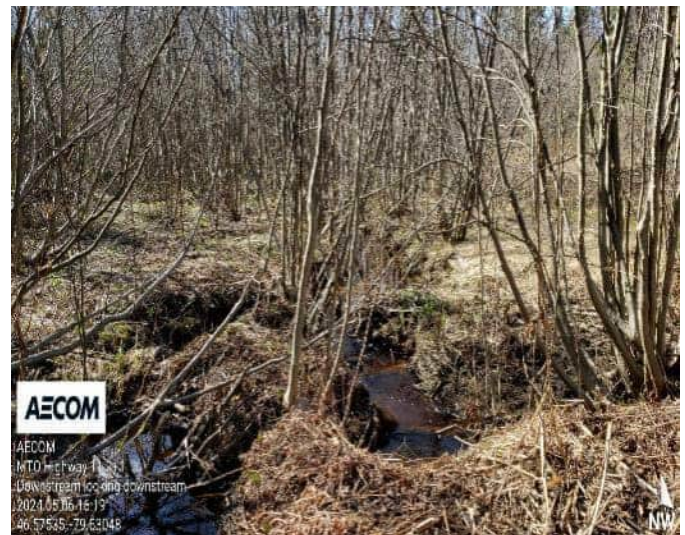
**Photograph 52** ↑

**Notman – 16+060:** May 6, 2024. View of downstream ZDA. Facing downstream (west) along channel in thicket.

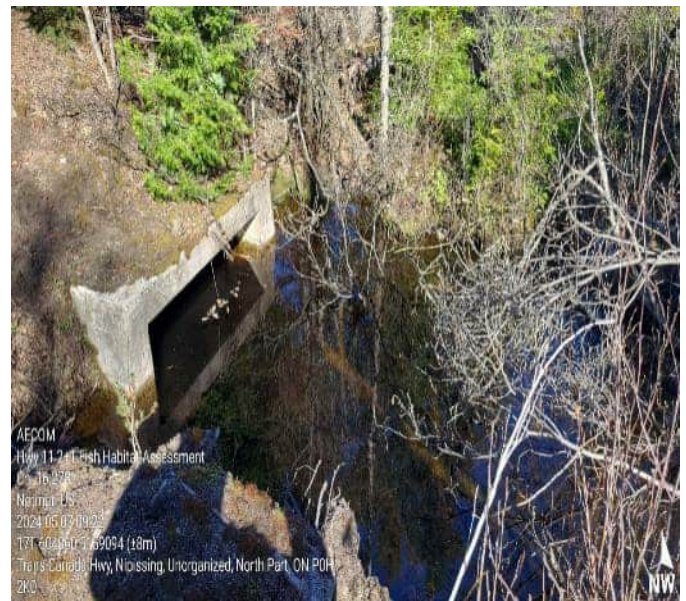
**Photograph 54** ↑  
Notman – 16+278 : May 7, 2024.  
View of pool at culvert inlet.

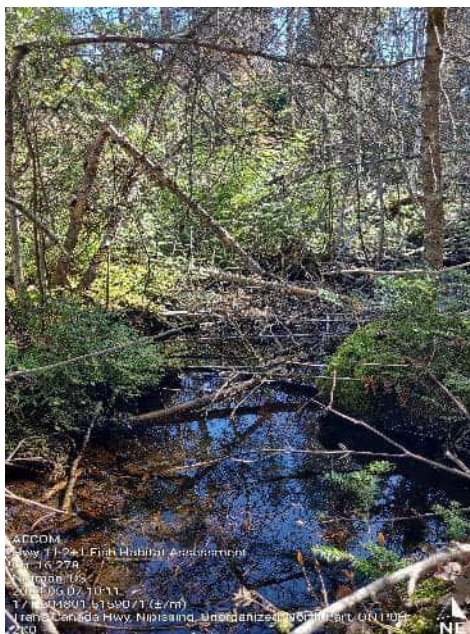
**Photograph 55** ↑  
Notman – 16+278: May 7, 2024. View of channel in downstream ZDA, facing downstream (west).
